ADVANCED OVERRUNNING CLUT; H TECHNOLOGY, (U)

DAAJ02-74-C-0028

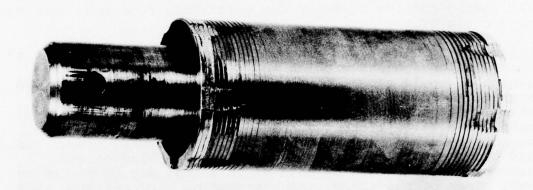
component to plate. Note the "bubbling" effect in the spring's teaser coil lubrication slots. This is an indication of poor plating quality. The effect of the silver-plating chipping was that in general the output housing sustained the greatest damage in the form of score marks on the inner bore, whereas the spring outside diameter was relatively free from scoring, as seen in Figure 84.

Figure 84. Spring and Output Housing After Differential-Speed Overrunning Test, Task I.

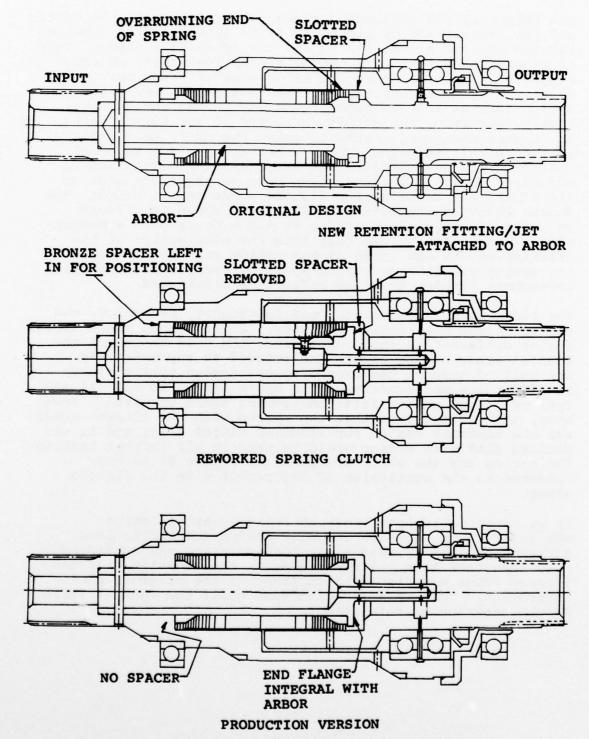
Examination of the problem of spring axial rubbing led to an alternate design for the spring clutch. The original design is at the top of Figure 87. In the original design, the arbor is attached to the input. Since the spring at rest has an interference fit with the arbor, the spring will remain in the same angular relationship to its arbor during overrunning, i.e., the spring will rotate with the input side of the clutch. During full-speed overrunning, the spring is at rest and rubbing takes place only on the teaser coils in contact with the output housing. During differential-speed overrunning, the spring rotates at the same speed as the input housing, with rubbing again taking place only on the teaser coils in contact with the output housing. A slotted spacer, guided on its outside diameter, is positioned between the end of the spring and the output housing. This spacer permits oil to pass through it to the spring's teaser coils and also acts as a sacrificial rubbing area for the spring during overrun. Relative motion is present between the overrunning end of the spring and this spacer. Therefore, if the spring touches the spacer in the axial direction during overrunning, drag is created.

Figure 87. Spring Clutch Redesign With Flanged Arbor.

The object of the redesigned spring arbors shown in the center and the lower parts of Figure 87 is to eliminate the rubbing between the end of the spring and the adjacent bushing. is accomplished with a flange on the spring arbor, as shown in Figure 87. The flange on the arbor restrains the spring axially and, most importantly, does not permit any relative motion between the end face of the spring and the output housing except on the outside diameter of the teaser coils. The center design of Figure 87 shows the modified clutch tested in this program. The flanged arbor was a reworked version of the original spring arbor. The modification consisted of drilling a lubrication hole on the input side of the clutch and riveting the flanged piece to the arbor. design shown at the bottom of Figure 87 shows the flange and arbor as a single piece as it might be made in a production model. It was felt that with the elimination of the friction on the end faces of the spring and the bushings the spring clutch drag torque would be reduced and the false engagement problem would be reduced or eliminated.

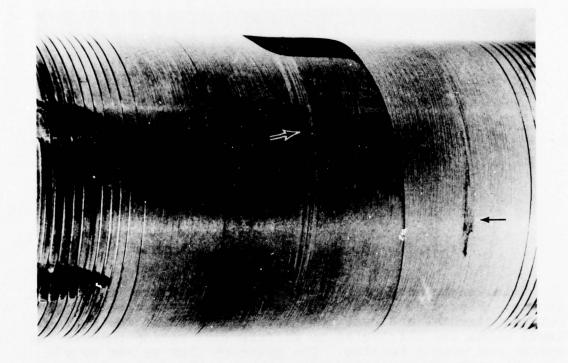
Figure 89. Spring Showing Score Marks From Contact With Output Housing.

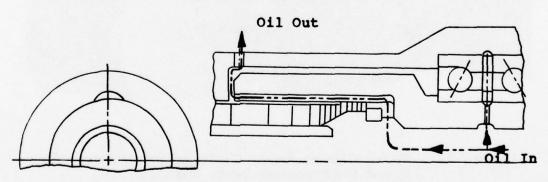
The false-engagement problem was eventually traced to another source. Figure 89 shows score marks located on the spring's outside diameter and near the central section of the spring. These marks are attributed to differential motion between the spring and output housing. The question then arises as to why the spring O.D. should score whereas the spring teaser coils, which have higher rubbing pressure, do not score. The answer lies in the lubricant flow path. As the input shaft speed increases, the centrifugal force acting on the spring causes the spring to expand outward. At the speed where the false engagement occurs, the center coils rub the output housing bore and, because there is no lubrication to this section of the spring, the O.D. scores. Figure 90 shows that the lubricant can escape prior to reaching the sections of the spring that scored. In fact, when the spring expands onto the output housing bore, the spring forms a seal that will not permit lubricant to pass to the center coils. Figure 90 also illustrates a solution using slots in the output housing bore to channel oil to the center spring coils (see Reference 1 for a more detailed discussion of spring clutch lubrication.

Redesign Distributes Oil to All Areas of Spring and Housing That Have Relative Motion

Figure 90. Spring Clutch Lubricant Flow Paths.

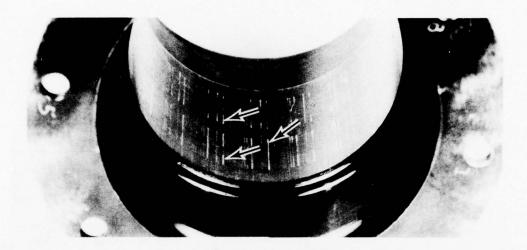
The second clutch to be tested in the Task I differentialspeed overrunning test was the sprag clutch. At the 100%
flow condition of .8 gpm for the sprag clutch, differential
overrunning tests were conducted for 3 hours at each of the
three differential overrunning conditions: 50, 67, and 75%
(10,000, 13,400 and 15,000 rpm input speeds and a 20,000 rpm
output speed). This test of the sprag clutch was run without
incident. Figures 91, 92, and 93 show the conditions of the
outer race, the inner shaft, and a typical sprag, respectively,
at the conclusion of the test. The marks on the outer race
at the sprag contact points were of negligible depth. The
inner shaft had sustained race wear in the form of tangential

Figure 91. Sprag Clutch Outer Race After Differential-Speed Overrunning Test, Task I.

Figure 92. Sprag Clutch Inner Shaft After Differential-Speed Overrunning Test, Task I.

score marks to a depth of .0002 inch, which is well within the permissible wear of approximately .001 inch for that unit. The typical sprag shown had an average bandwidth of wear of approximately .015 inch, which, when converted to depth of wear, is less than .0002 inch.

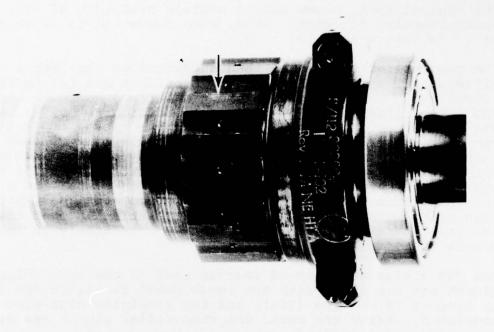
The most notable outcome of the differential-speed test was found on the cam shaft, as shown in Figure 94. For proper operation of a ramp-roller clutch in the overrunning mode, the overrunning wear area should be confined to a small bandwidth on the cam flat in the area where the roller contacts the cam flat. A small bandwidth of wear indicates that the rollers are in intimate contact with the outer housing and cam and have remained in contact for most of the test. Close inspection of the cam flats shown in Figure 94 shows that the bandwidth of wear on the flats is not in a concentrated line but extends from the start of the roller undercut pocket to the normal position, approximately one-third of the way up the flat. This wide bandwidth of contact indicates that the rollers along with the roller retention carrier were "chattering"; i.e., they were not in intimate contact with the outer housing and the cam flat but were oscillating back and forth, forcing the spring and plunger assembly away from its proper operating position. Further evidence of overrunning in several different positions is seen in the photograph of the leading edge of the retention cage roller pocket in Figure 95. Figure 96 shows the outer housing bore. The flake-like particles are the result of a mixture of hot oil and fine metal from the rollers and the carrier which tend to gather in that area of the outer housing (oil drain is from the opposite side of rollers).

Figure 94. Ramp-Roller Clutch Cam Shaft After Differential-Speed Overrunning Test, Task I.
